Extractives industry

2024/25 Q4

WORKSAFE
Mahi Haumarū Aotearoa

About this report

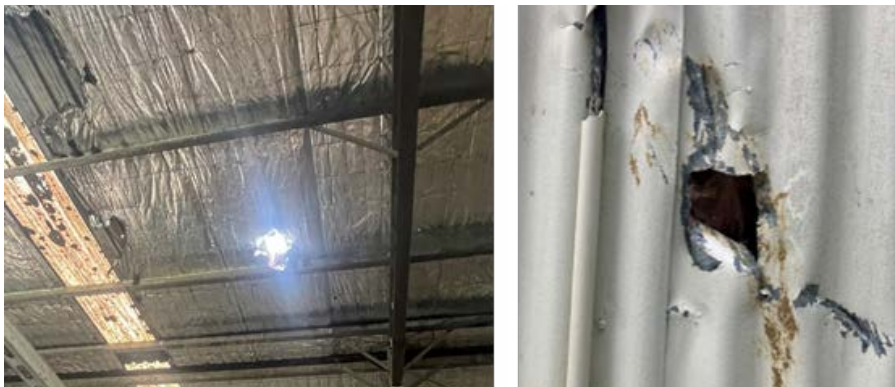
FIGURE 9:
Examples of fly rock damage

A flyrock incident occurred during a scheduled blast at a limestone quarry. No injuries were reported. However, the flyrock caused damage, to light vehicles and both on-site and off-site buildings.

The neighbouring property was a commercial business and had 29 staff spread across the site at the time of the incident. One of the buildings on the neighbouring property closest to the quarry (-480m) had four holes in the roof from flyrock damage.

A formal risk assessment should be completed for each blast, to identify the hazards and control measures at each stage, including the extent of the blast exclusion zone during the firing sequence.

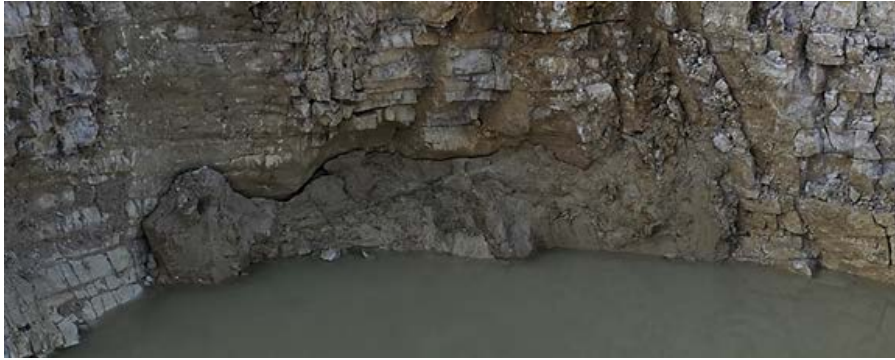
FIGURE 10:
Clay pocket within
limestone geology

Site personnel perceived the geological variation as typical, based on long-term geological uniformity historically observed at the location.

The variation in limestone geology observed on the face was not recognised as a potential clay pocket, leading to a misinterpretation of geological conditions.
