**FACT SHEET**

## **CAUTION – CEILING BATTENS DO NOT PROVIDE FALL PROTECTION**

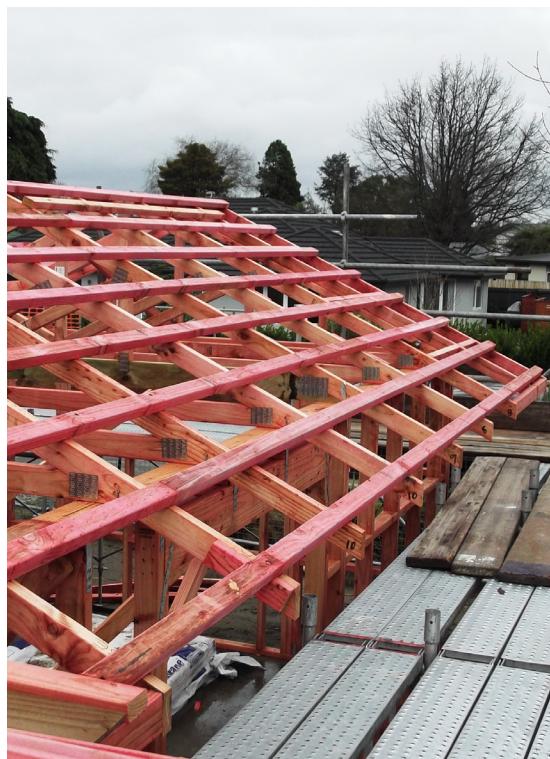
**It has come to our attention that some builders are using or are considering using ceiling battens as a method of fall protection when working on the roofing structure of the building. Both metal and timber ceiling battens are generally a lightweight element designed to provide support for ceiling linings and not to sustain the loads imposed by a person falling.**

**Please note that this only refers to purlins and battens as part of the roofing structure not the ceiling structure (see photo).**

These guidelines provide details on a range of solutions that can be used, including reducing the spacing between purlins/roofing battens at a maximum of 500mm.

Where Inspectors find builders are relying on ceiling battens as a method of fall protection a **Prohibition Notice** will be issued requiring the builder to use a safer method of working such as temporary work platforms, safety mesh and soft landing systems.
