Risk involved when working near buried power cables

This safety alert highlights the health and safety risks involved with working near buried power cables and the need to carefully develop permit protocols.

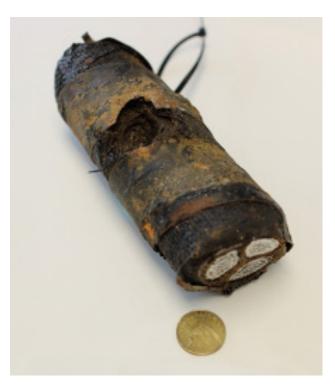
In July 2020, a worker on the City Rail Link project in Auckland's CBD hammered a piece of reinforcement rod into a former public footpath area. The rod connected with an underground 11kv electrical cable, and smoke started rising from the area around the rod. Power was lost to the surrounding neighbourhood.

The company involved had previously identified the location of the cable, and had a permit-to-dig system. However, the permit system only considered excavation below ground and not the penetration of the ground without digging. Because the workers were not digging below the ground, they did not use the permit system which would have identified the location of the buried cable.

Damaged cable

- undertake a task-based risk assessment before beginning work and make sure they involve the workers doing the job
- ensure all services are marked with paint during all relevant phases of the project
- have a plan on site showing the location of all utility services
- ensure that any permit-to-dig system also includes items being driven into the ground (for example, pins, stakes or waratahs)
- ensure supervisors are competent to manage a high-risk incident.
