Asbestos information for builders

Places where asbestos is often found

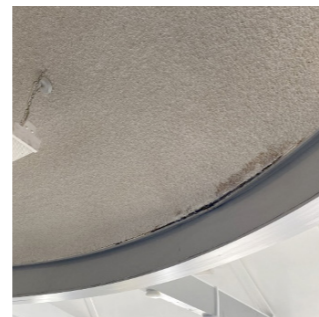
Sprayed coating on the ceiling
Common to many houses

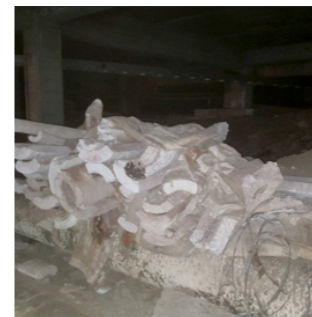
Loose lagging in basement
High risk of excessive contamination

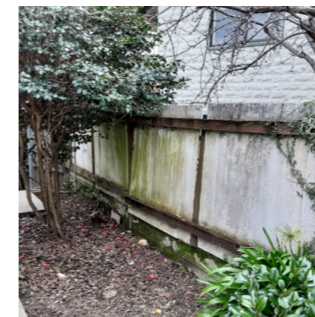
AC fencing in bad condition
Common to many houses

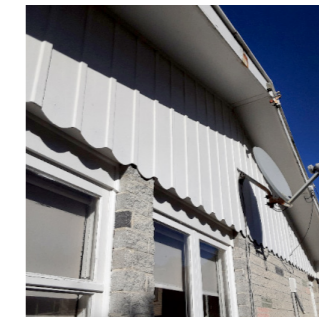
AC soffit and gable
Common to many houses

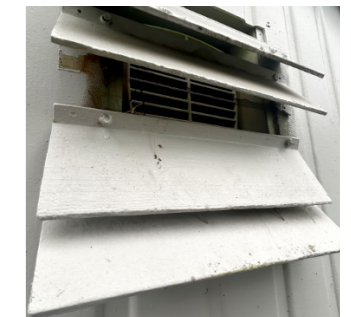
ACM type cladding and louvres
Common to light commercial

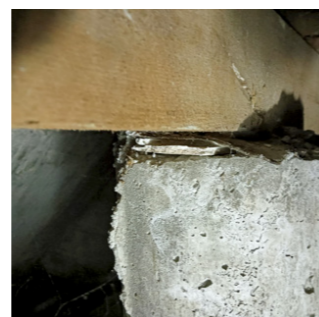
Packing AIB and bitumen
Common to houses on piles

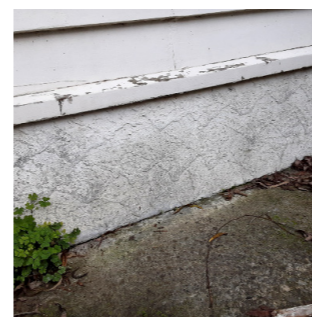
Backing boards
Common to many houses particularly state houses

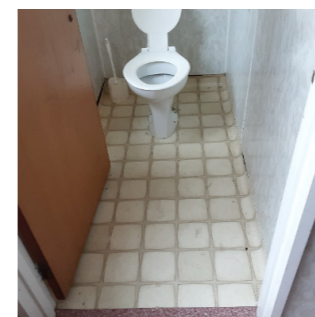
Paper backed vinyl
Floor covering in bathrooms and wet area may contain asbestos in the lino or backing. The asbestos fibres in the backing can become airborne when lifted

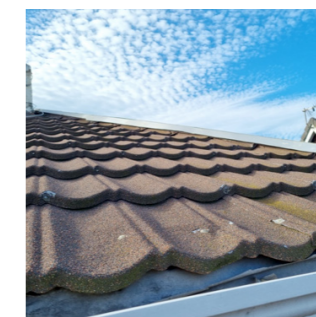
'Decramastic' metal pressed tile
Pressed metal roof tiles commonly known as decramastic tiles may have asbestos in the base mastic bitumen

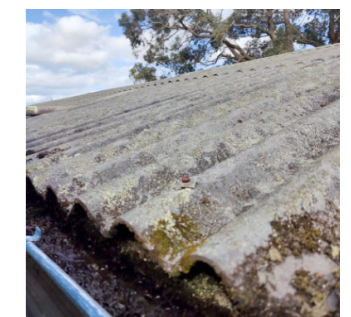
Super six roof
Corrugated cement sheet containing asbestos commonly known as super 6 has asbestos in the composition. This type of product is approximately 50 years old and has reached the end of its economic life
