Fatal incident in pump shed explosion

This bulletin is for people whose work involves water pump systems.

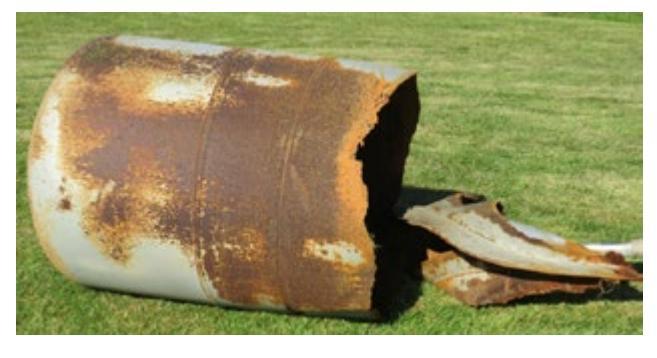
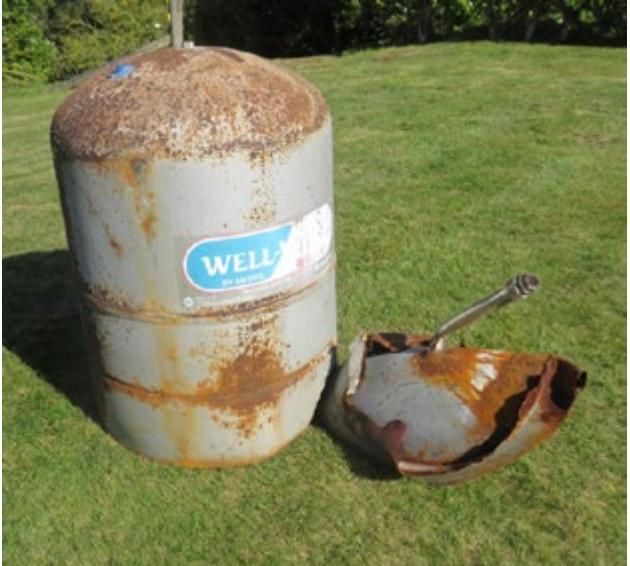
The cylinder was over 20 years old. It was in a very poor condition showing severe pitting corrosion to the rear external side-wall of the cylinder and in the lower third of the internal surface.

The steel mounting skirt at the base of the cylinder was almost totally corroded. The absence of most of the mounting skirt meant the cylinder was virtually free floating on its pipework causing additional stress to the base of the cylinder.

The pump quickly over-pressured the cylinder beyond its pressure capability, which together with the condition of the cylinder resulted in the catastrophic failure of the pressure cylinder.

- We strongly recommend that associated service personnel completely check the entire water pump assembly to check the integrity of older parts and ensure that the introduction of new parts are appropriate for the existing set-up.

- Where a single function pressure control switch –
 'loss of prime' shut off is chosen, this switch should be installed to control the low pressure start-up sequence of the pump only, with a high pressure cut-out switch installed 'in-line' to control the high pressure cut-out protection.

- Consider the age and potential condition of pressure components when maintenance is being planned and/or carried out.
- Visually inspect older pressure cylinders for signs of surface deterioration with surface rust and/or severe pitting corrosion.

- Where components are replaced, refurbished or upgraded, confirm that the pressure safety limits of individual items are compatible and not compromised without the fitting of appropriate safety devices, i.e.
 Pressure Relief Valve (PRV).
